Re: Claim #: 040515008195
Insured: Versatube Corporation
4755 Rochester Rd., Troy, Michigan 48085
Our File: Versatube Corp

Subject: Versatube Corp. Sheppard Report, Beam Repairs, and Codes

VERSATUBE STAMPING PLANT
INSPECTION OF FIRE DAMAGE REPAIRS
4755 ROCHESTER ROAD, TROY MI

Versatube Stamping Plant
Fire Damage Repair Inspection
by Stephen M. Rudner, P.E. on June 2, 2017

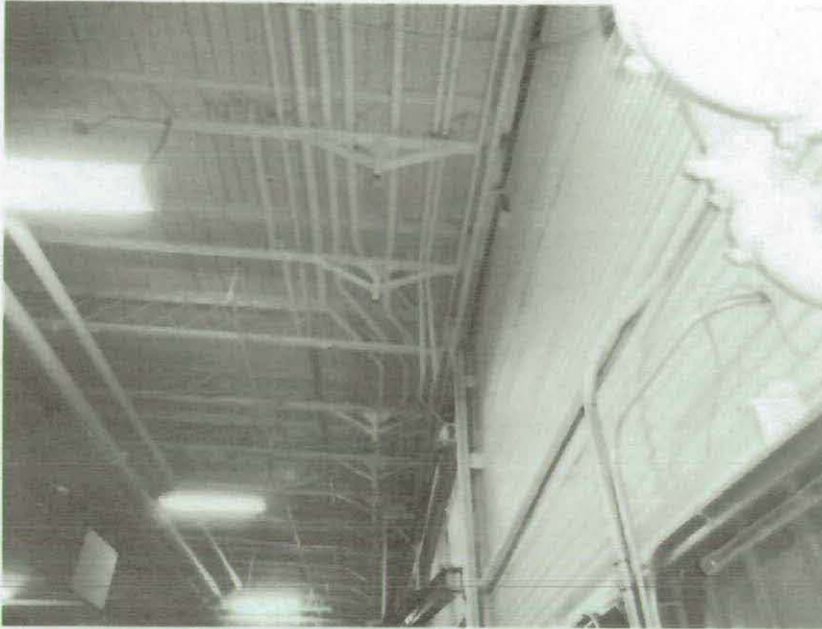
Photo #1 - Looking west on south side of wall. Area of fire was on mezzanine attached to the wall on the right of this photo.

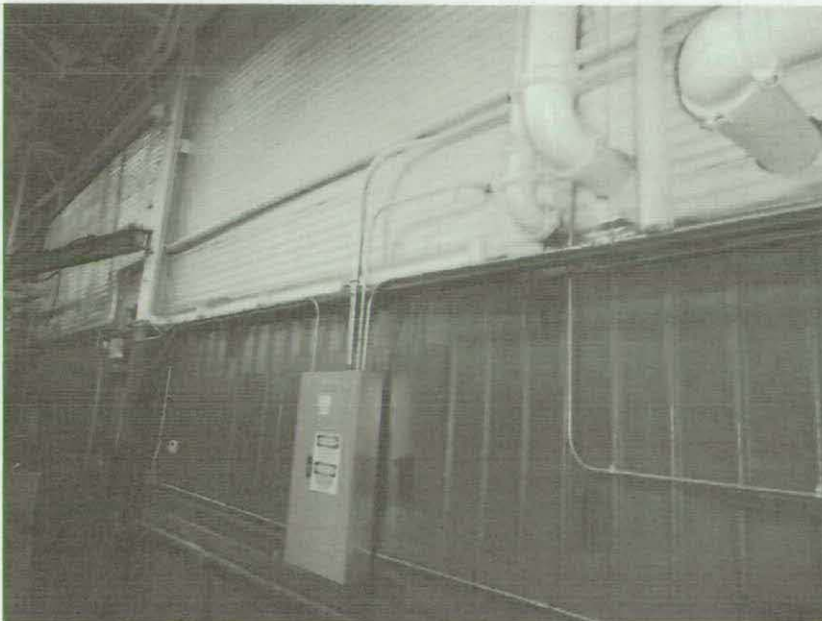
Photo #2 - Looking west on south side of wall. Area of fire was on mezzanine attached to the wall on the right of this photo.

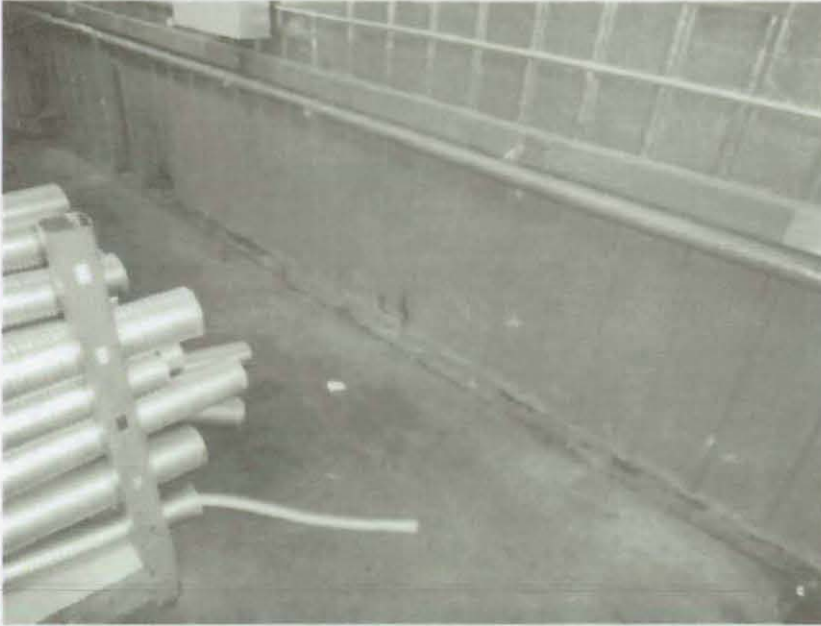
Photo #3 - South side of wall. Burned siding near floor is location of column base plates at columns added after the fire.

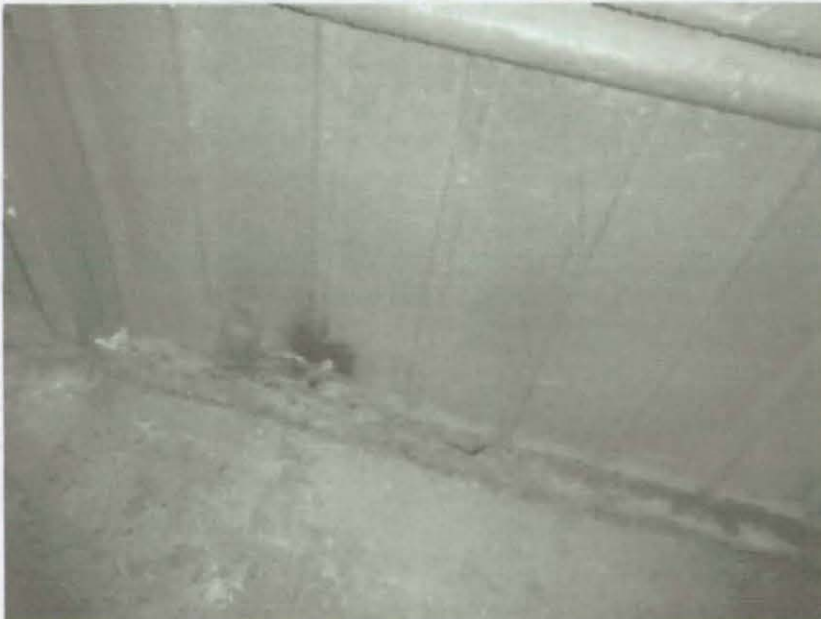
Photo #4 - South side of wall. Burned area is location of base plate of column added after fire.

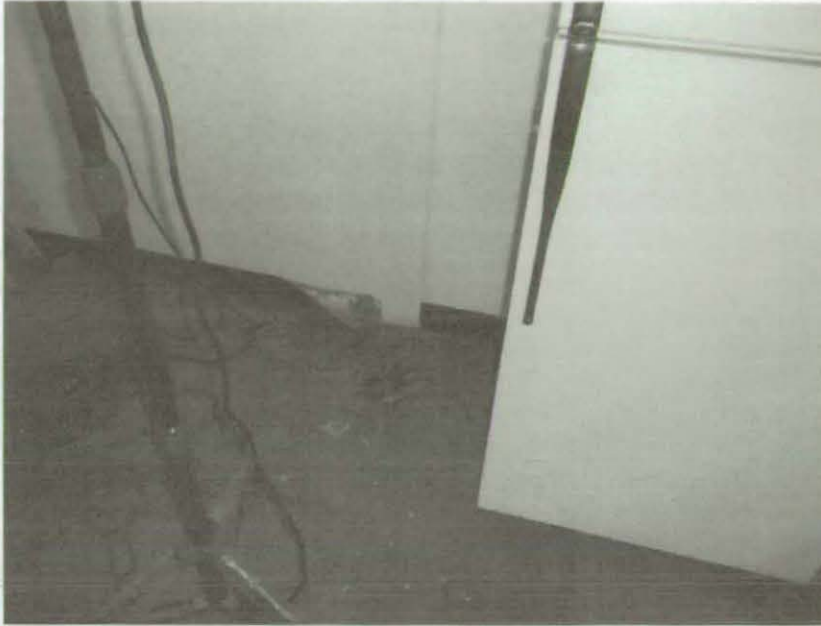
Photo #5 - North side of wall at west added column looking south.

4. Eliminate the two added columns and repair the locations along the existing second floor beam where the saw cut into the sides of the tube. The removed section of angle ledger should be spliced back in and the saw kerfs repaired and the wood nailer supporting the second-floor joists should be spliced back together as well.

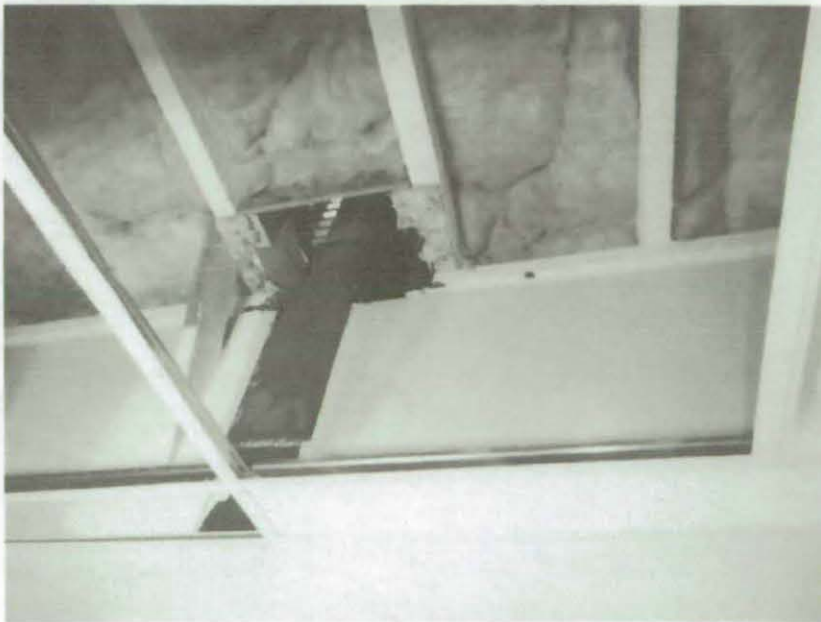
Photo #6 - West of two added columns at column splice.

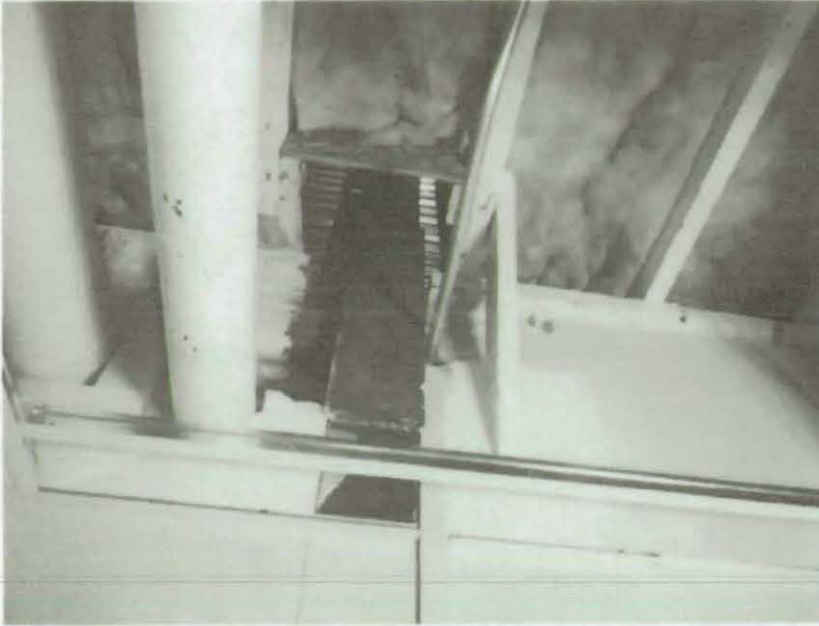
Photo #7 - East of two columns at column splice.

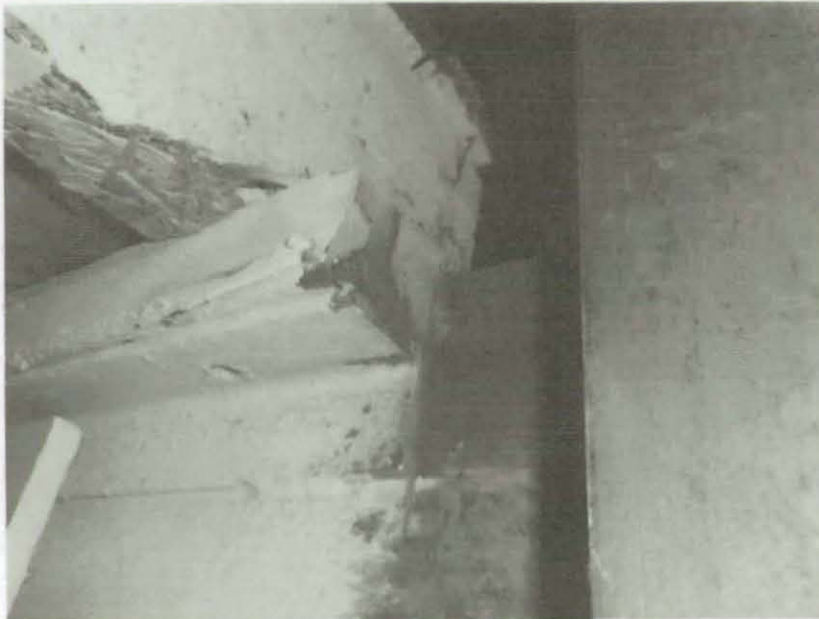
Photo #8 - East added column. Close-up of saw cuts where continuous angle supporting wood second floor joist was cut. Note saw cut into existing steel beam.

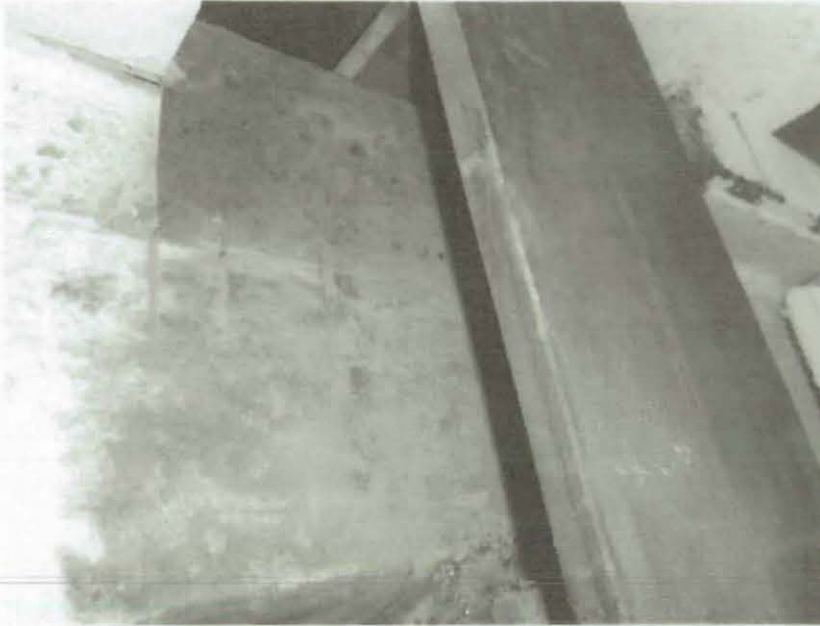
Photo #9 - Close-up of column splice at east added column. W8x18 column is interrupted at tubular steel beam supporting second floor joist on north side of wall. 5/8" x 6" x 24" plate added to flanges each side of column splice but only really welded horizontally at top and bottom of plate. Side welds are quite poor.

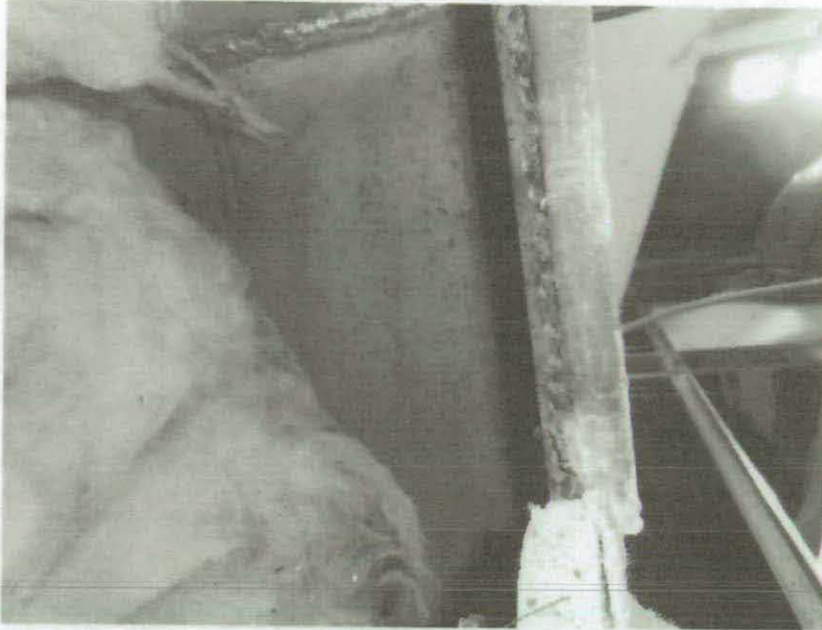
Photo #10 - Side welds between 5/8" x 6" x 24" plate are poor welds.

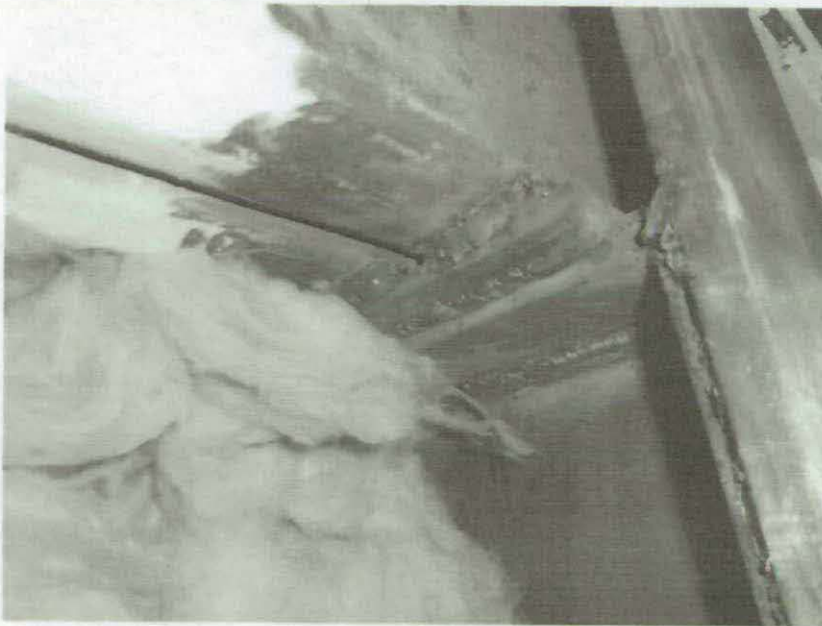
Photo #11 - Side welds between 5/8" x 6" x 24" plate are poor welds.

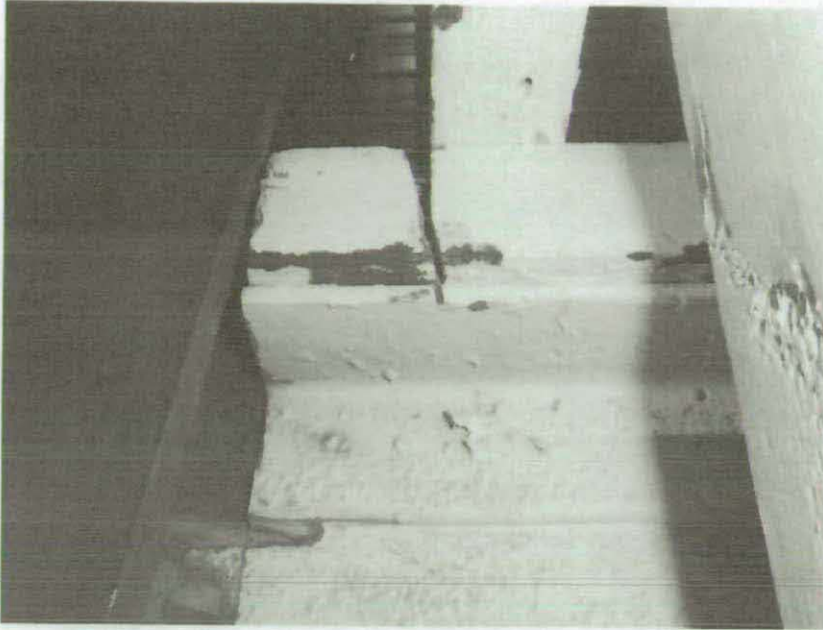
Photo #12 - Cut of angle supporting floor joist on west side of east column.

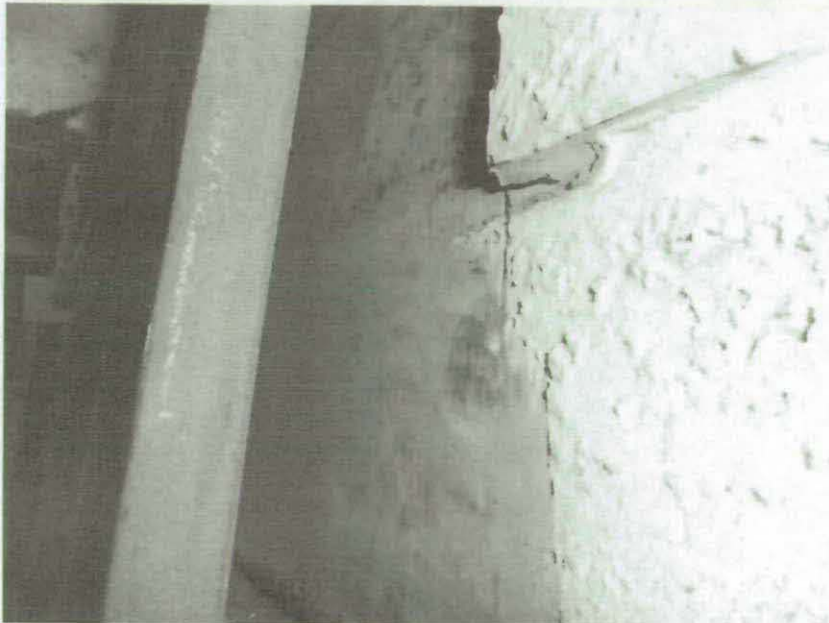
Photo #13 - Close-up of tubular beam at west side of east column looking SE.
Note saw kerf in wall of tubular beam.

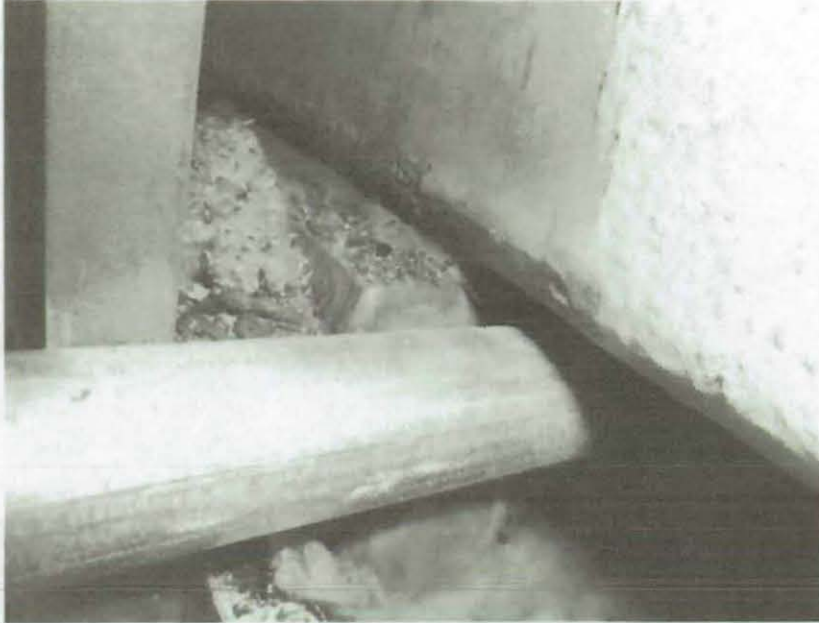
Photo #14 - Weld of tubular beam to lower half of east column looking SE.

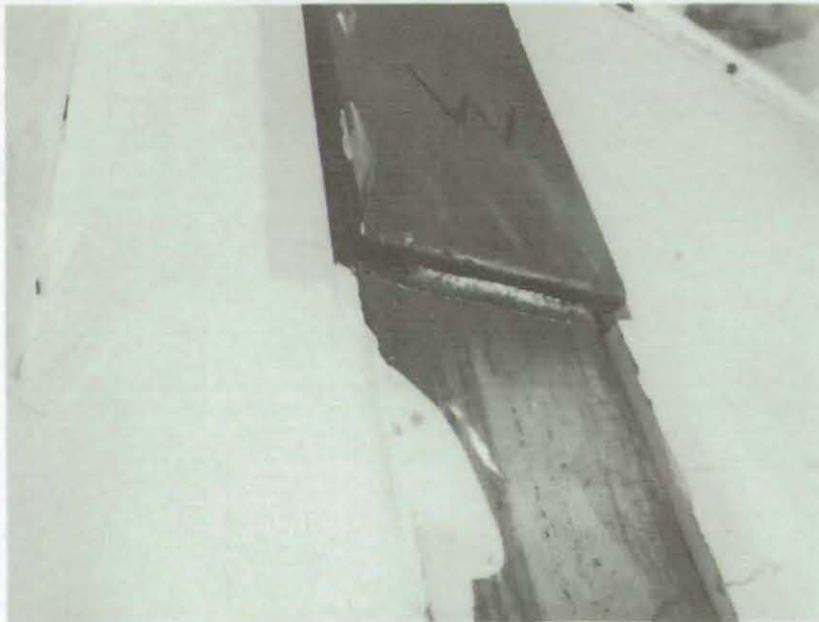
Photo #15 - West added column. Weld of bottom of 5/8" x 6" x 24" plate to flange of added column.

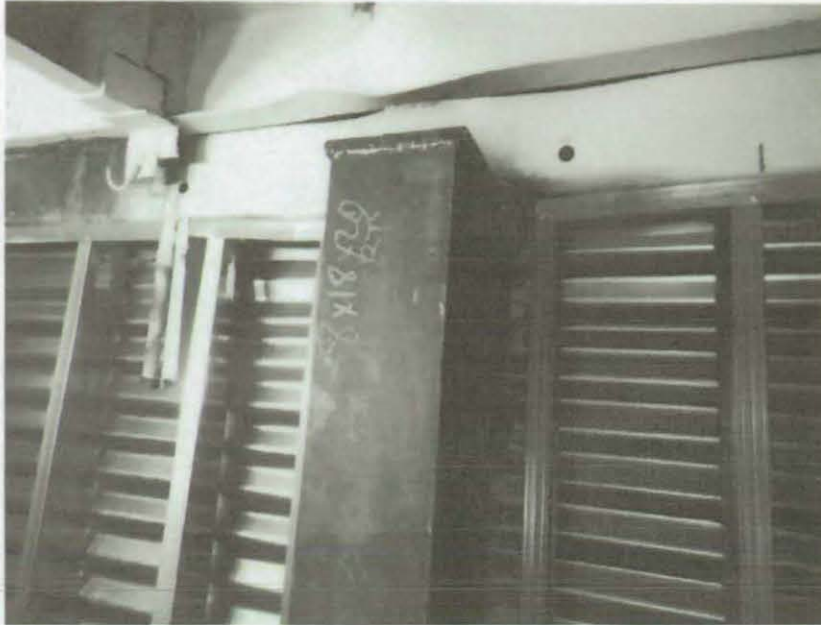
Photo #16 - Top of west column. Note buckled flange of beam beyond.

2. Remove and replace the roof beams such that they span clear between the original columns. This beam is made up of two tubular beams plus a continuous channel welded along the north side of the north tube beam. Weld the steel joists of the south high bay to the new beam. Provide wood nailers for attaching wood roof decking as required. The replacement beams should be sized based on calculations prepared by a structural engineer.

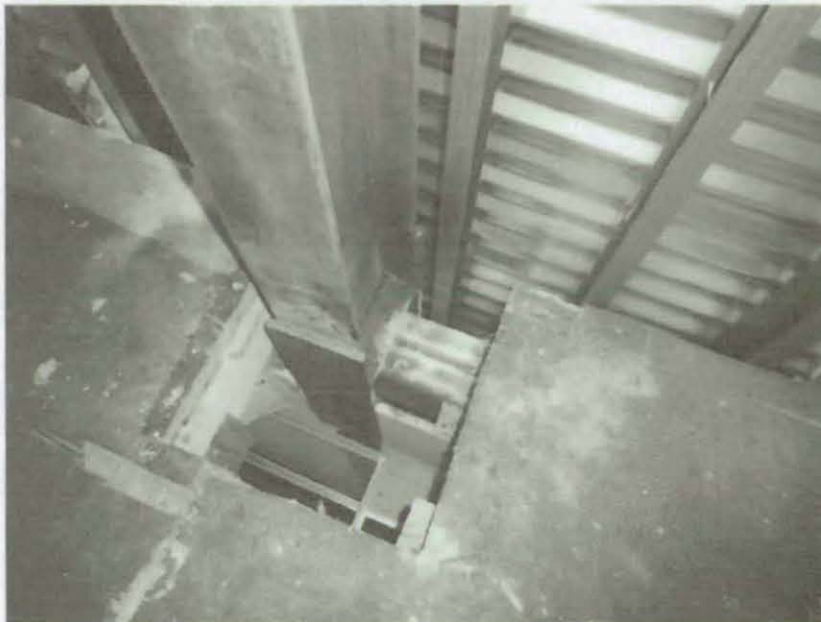
Photo #17 - Looking down at column splice of west column. Note tubular beam appears to be two tubes or two cold formed channels face to face.

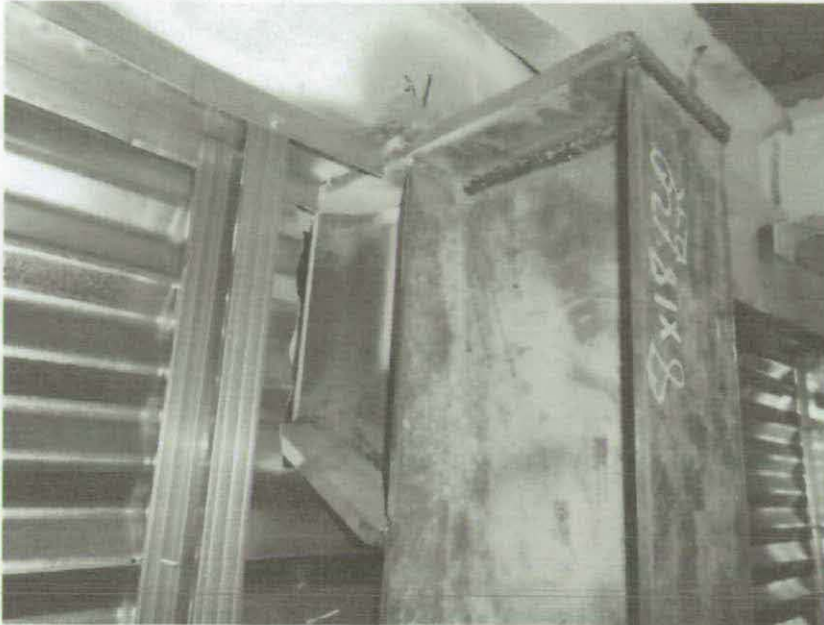
Photo #18 - Top of west column looking southwest. Column has a bracket on top to support the roof beam as the roof beams are offset from the column.

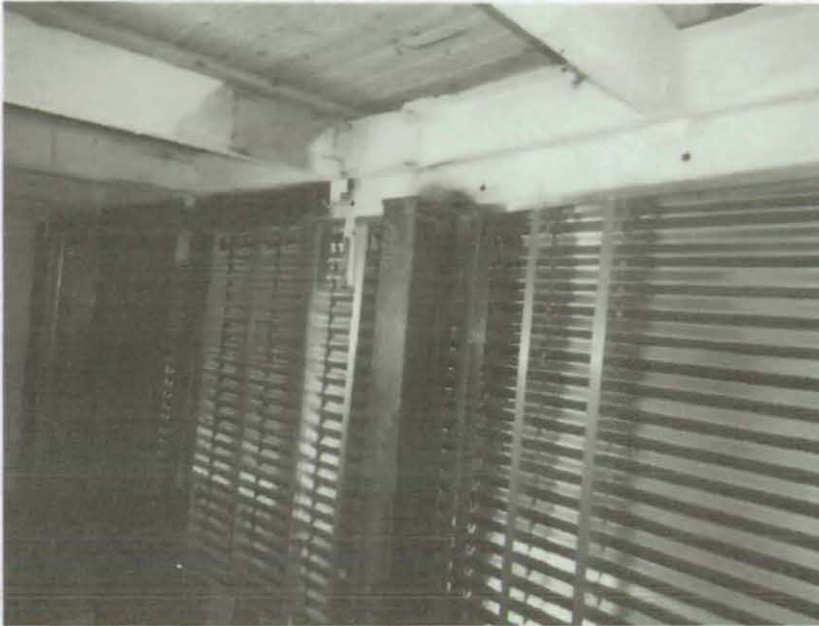
The repair work that was done was defective in that the sagged roof beam was left in place. Also, the welding of the spliced columns where they are interrupted by the tubular floor beam and the welding of the bracket at the top of the column is questionable as seen in my attached photos. The deformed twin tubular roof beam parallel with the wall line and twisted channel joists of the roof structure above the second-floor area should not have been re-used.

Photo #19 - West of two added columns at approximate 1/3 points of roof beam that sagged due to fire. Wood roof deck was replaced. However, the steel support structure was not straightened. It has sagged approximately 3 1/2 inches in six feet.
